Interpretation and Evaluation Services

Determined Stratigraphic and Structural Features for Development Borehole Drilling Programs

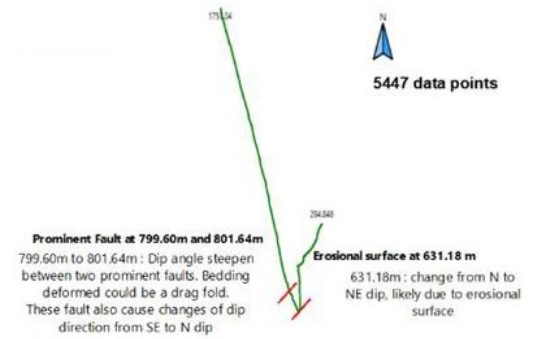
The dip azimuth vector walkout plots are useful tools in identifying changes in the structural dip direction along the borehole. The plots also help identify abrupt changes in the structural dip azimuth.
