Thru-Tubing Fishing Tools

Retrieve PX Plug and Slickline BHA, Save \$1 million Recompletion Job

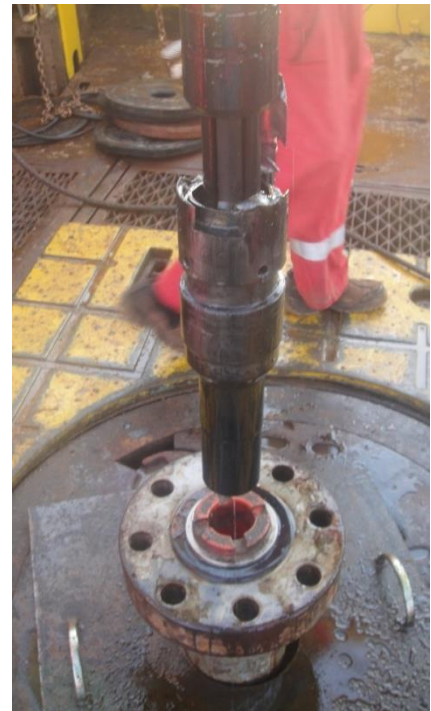
A Weatherford thru-tubing fishing services team retrieved a PX plug that was stuck downhole. The successful operation eliminated the need for a costly recompletion operation and saved the operator 7 to 8 days of rig time.
